# **CITY OF LAGUNA HILLS TRAFFIC COMMISSION**

## **REGULAR MEETING AGENDA Wednesday, March 17, 2021 – 7:00 PM**

***Traffic Control & Operational Review:***  
***Nellie Gail Equestrian Center Driveway/Equestrian Crossing Location, in Laguna Hills, CA***

**Multiway Stop Sign Warrants Analysis – Nellie Gail Road at Empty Saddle Drive, in Laguna Hills, CA**

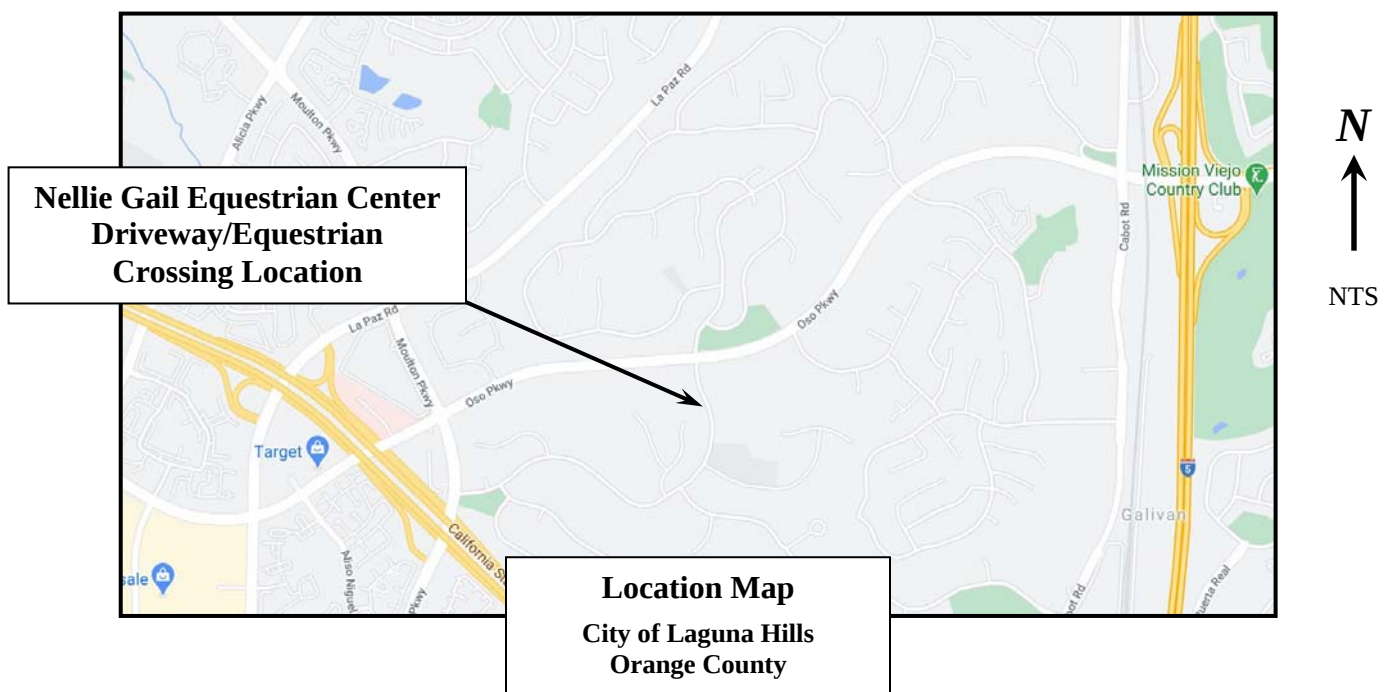
The location is a typical driveway intersection with Nellie Gail Road running in the north-south directions and the Equestrian Center driveway running in the east-west directions, on the east side of Nellie Gail Road. The intersection is located west of the I-5 Freeway and south of Oso Parkway (*see Location Map below*). The location is entirely within the City of Laguna Hills jurisdiction. At the present time, there are no stop controls on Nellie Gail Road (i.e., it is uncontrolled); however, there is an existing Rectangular Rapid Flashing Beacon (RRFB) push-button warning light crossing system for the equestrian crossing location.

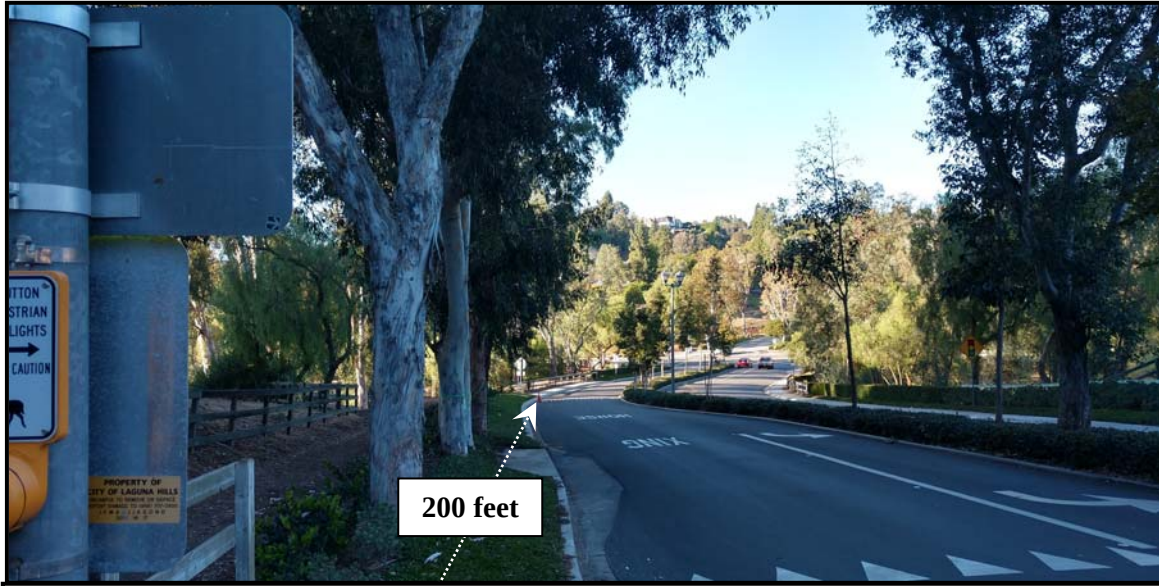
**Eastbound EQUESTRIAN CENTER DRIVEWAY (Looking North) @ NELLIE GAIL ROAD**

Driver sight distance was measured from the side-street approach, as westbound traffic on the Equestrian Center driveway is required to stop, before proceeding to make a left or right-turn onto Nellie Gail Road. The measured distance was derived from the stopping sight distance guidelines found in the California MUTCD (*see Appendix D*). In this reference, a 25 MPH roadway speed recommends a minimum Stopping Sight Distance of 155 feet. However, as shown, the 85<sup>th</sup> percentile speeds exceed the 25 MPH posted speed limit. Therefore, a 30 MPH speed limit was used as a more conservative measure, which has a minimum sight distance of 200 feet. This distance was used when looking towards approaching, uncontrolled traffic along Nellie Gail Road. More specifically, this stopping sight distance was field-measured from a typical ‘stopped’ vehicle location at the Equestrian Center driveway looking towards the oncoming lanes of cross-traffic on Nellie Gail Road. An orange cone was placed at this distance and a photograph was taken from a stopped driver’s perspective (i.e., approximately 4.5’ high above ground).

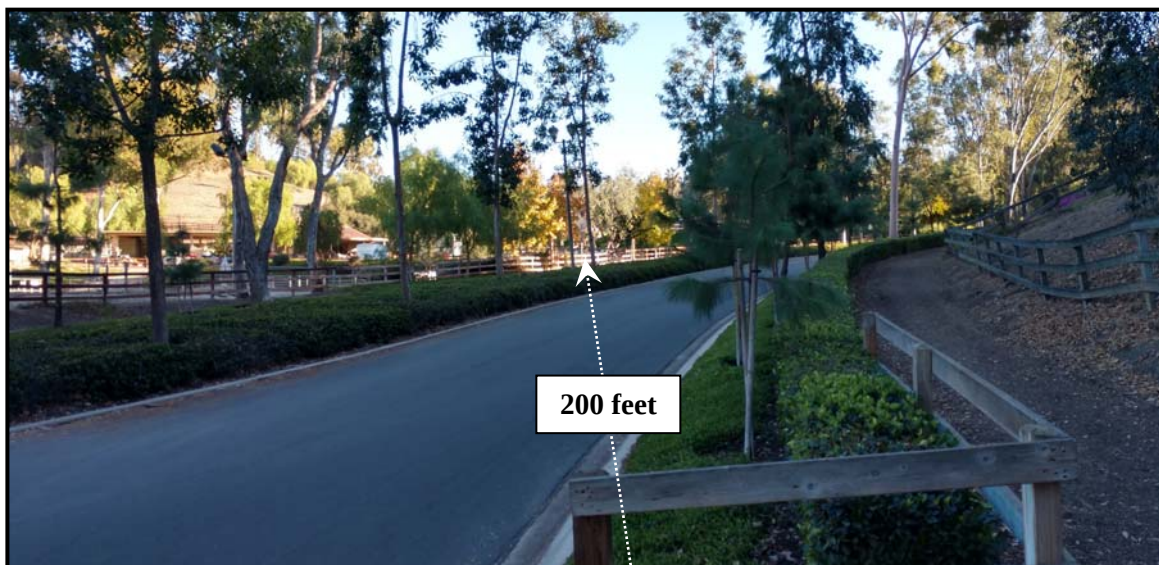
**Eastbound EQUESTRIAN CENTER DRIVEWAY (Looking South) @ NELLIE GAIL ROAD**

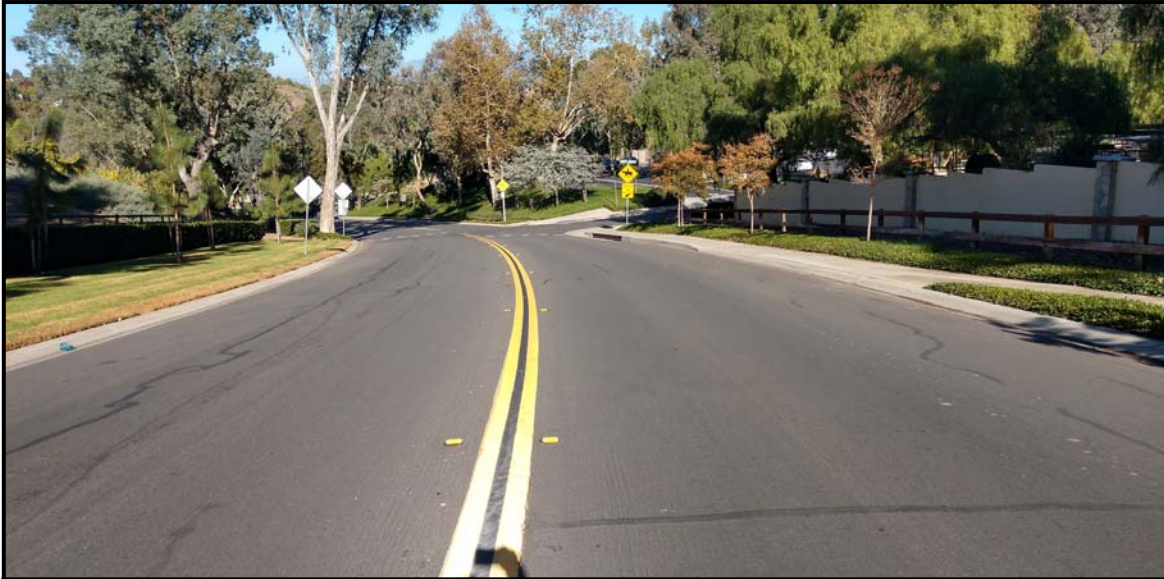
**NELLIE GAIL ROAD (Looking Northbound) @ EMPTY SADDLE DRIVE**

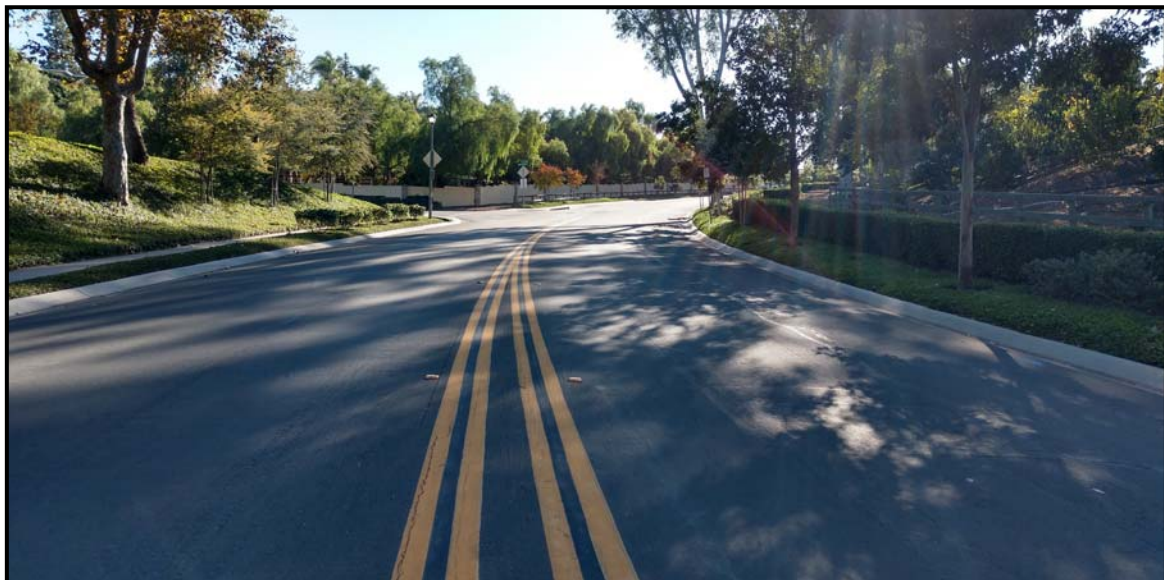
**NELLIE GAIL ROAD (Looking Southbound) @ EMPTY SADDLE DRIVE**

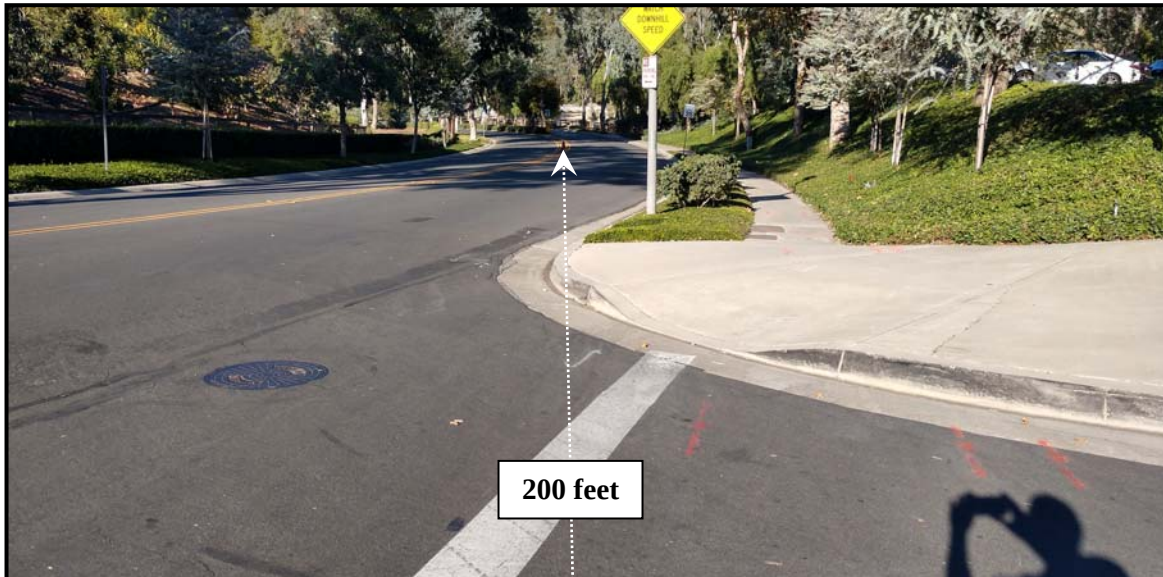
**Westbound EMPTY SADDLE DRIVE (Looking North) @ NELLIE GAIL ROAD**

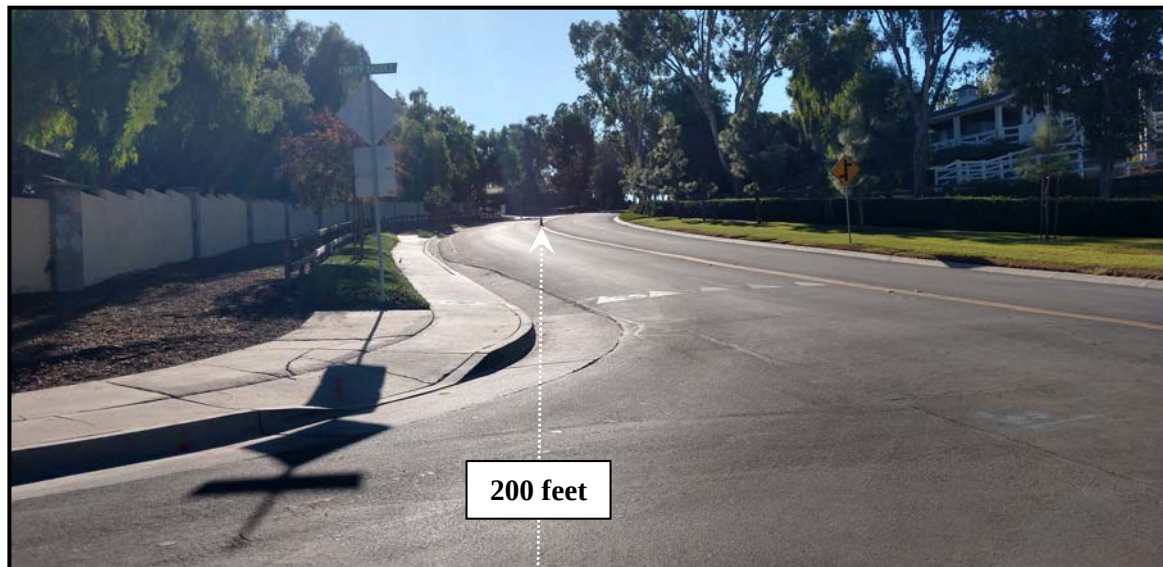
**Westbound EMPTY SADDLE DRIVE (Looking South) @ NELLIE GAIL ROAD**

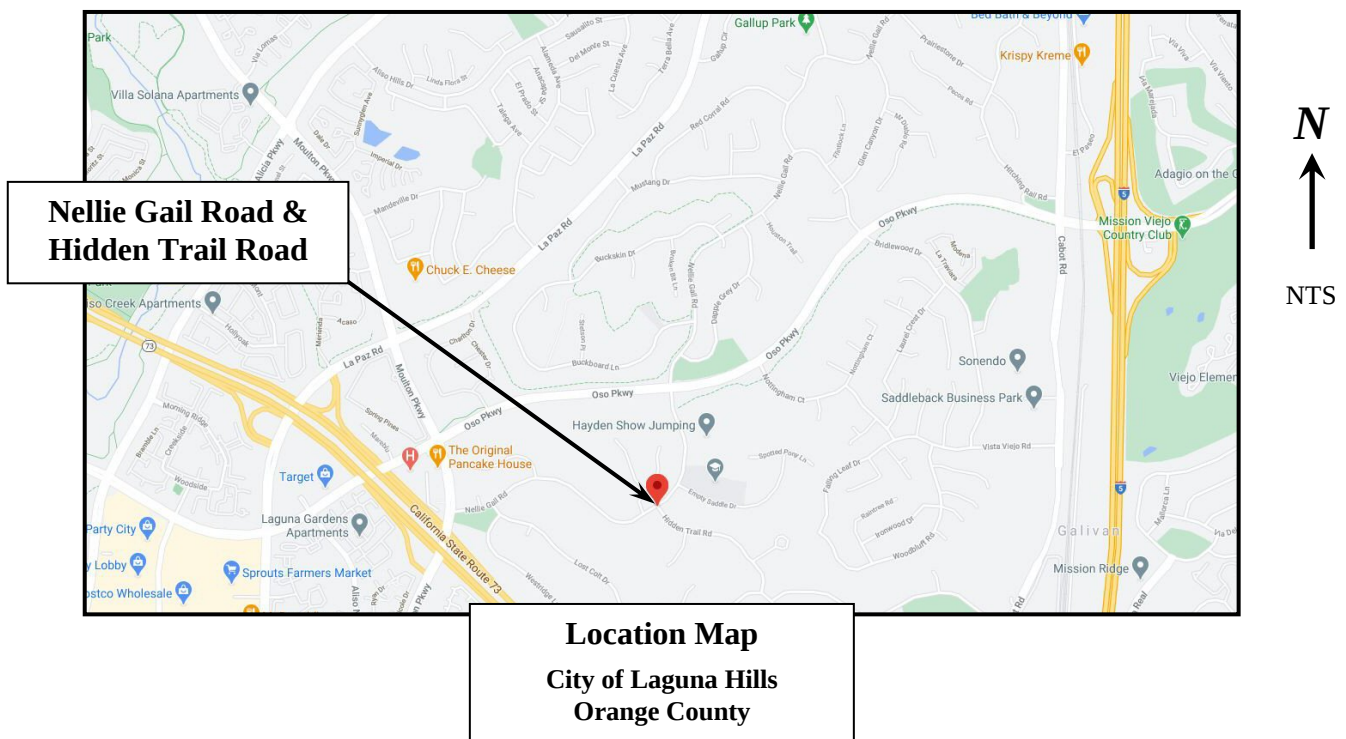
The location is a typical T-intersection with Nellie Gail Road running diagonally in the north-south directions and Hidden Trail Road running in the east-west directions. The intersection is located west of the I-5 Freeway and south of Oso Parkway (see *Location Map below*). The intersection is entirely within the City of Laguna Hills jurisdiction. At the present time, there is a one way stop control on Hidden Trail Road (i.e., Nellie Gail Road is uncontrolled).

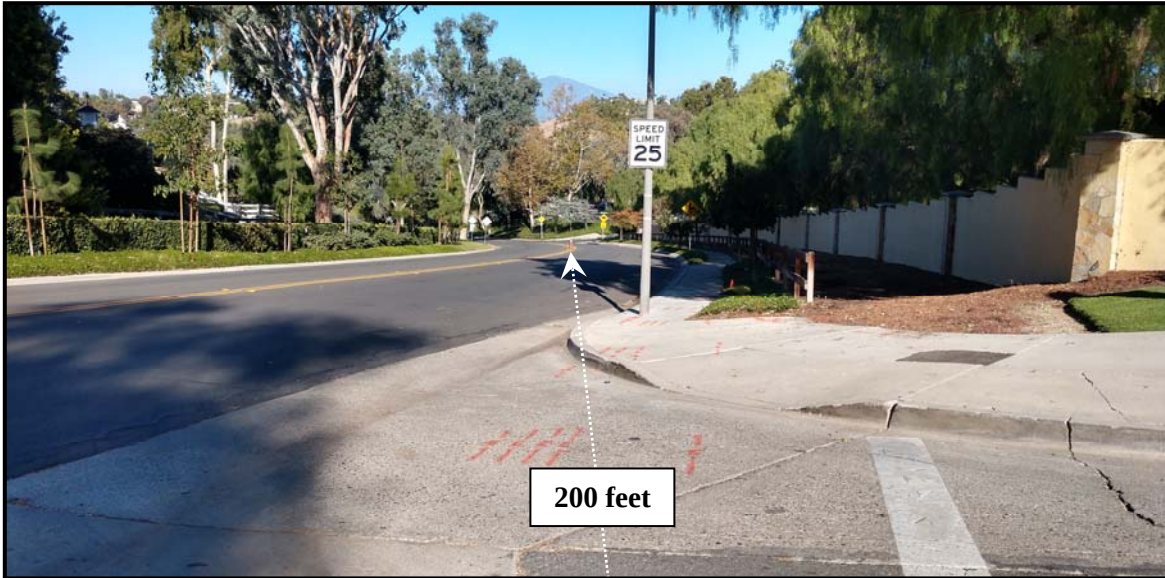
**Westbound HIDDEN TRAIL ROAD (Looking North) @ NELLIE GAIL ROAD**

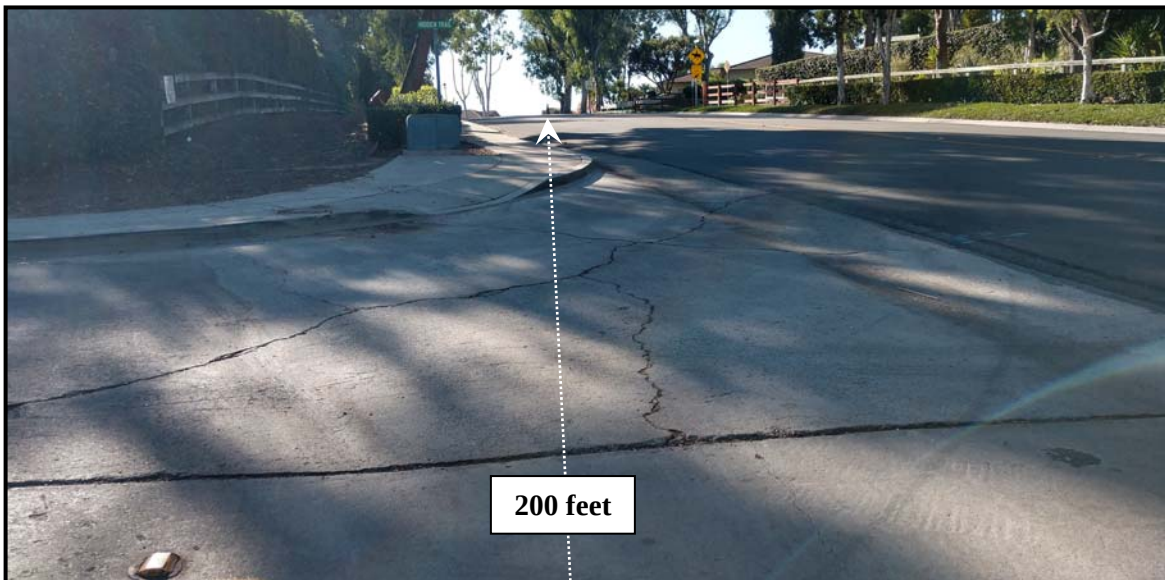
**Westbound HIDDEN TRAIL ROAD (Looking South) @ NELLIE GAIL ROAD**

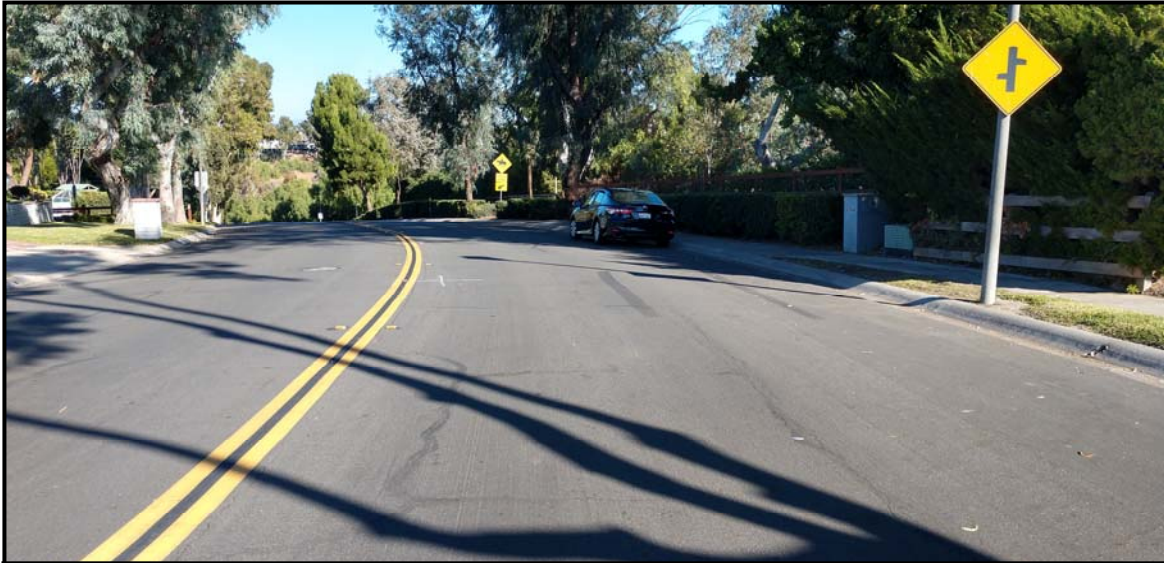
NELLIE GAIL ROAD (Looking Northbound) @ ROCKING HORSE LANE

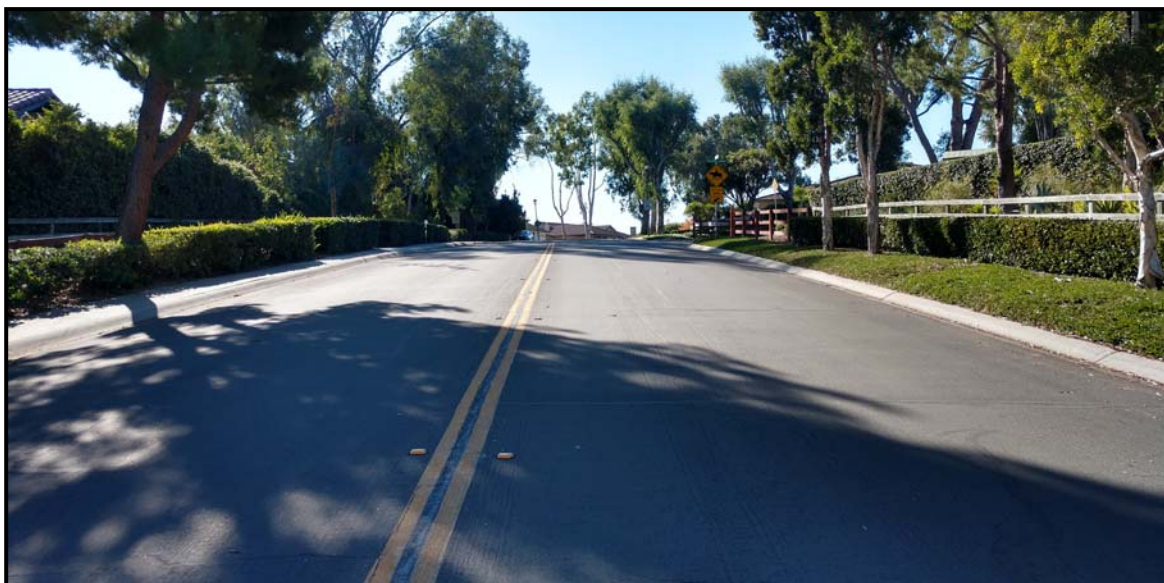
NELLIE GAIL ROAD (Looking Southbound) @ ROCKING HORSE LANE

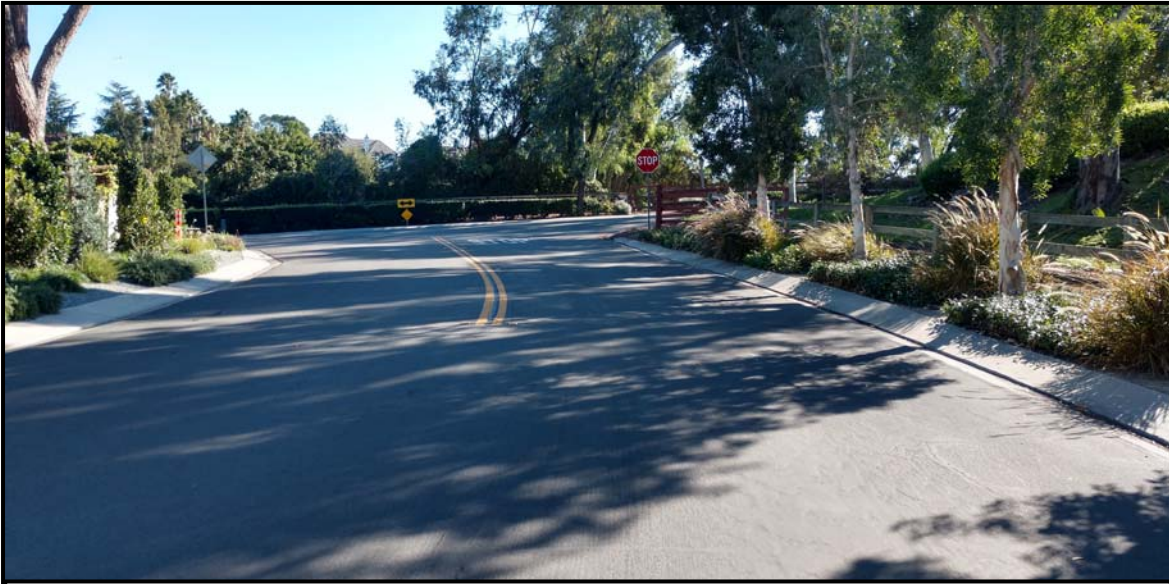
ROCKING HORSE LANE (*Looking Eastbound*) @ NELLIE GAIL ROAD
