**ISSUE: STOP SIGN INSTALLATION ANALYSIS AT BUCKSKIN DRIVE AND  
BROKEN BIT LANE**

**Subject: Stop Sign Analysis at the Intersection of  
Buckskin Drive and Broken Bit Lane**

# MULTI-WAY STOP CONTROL WARRANTS ANALYSIS BUCKSKIN DRIVE AT BROKEN BIT LANE IN THE CITY OF LAGUNA HILLS, CA

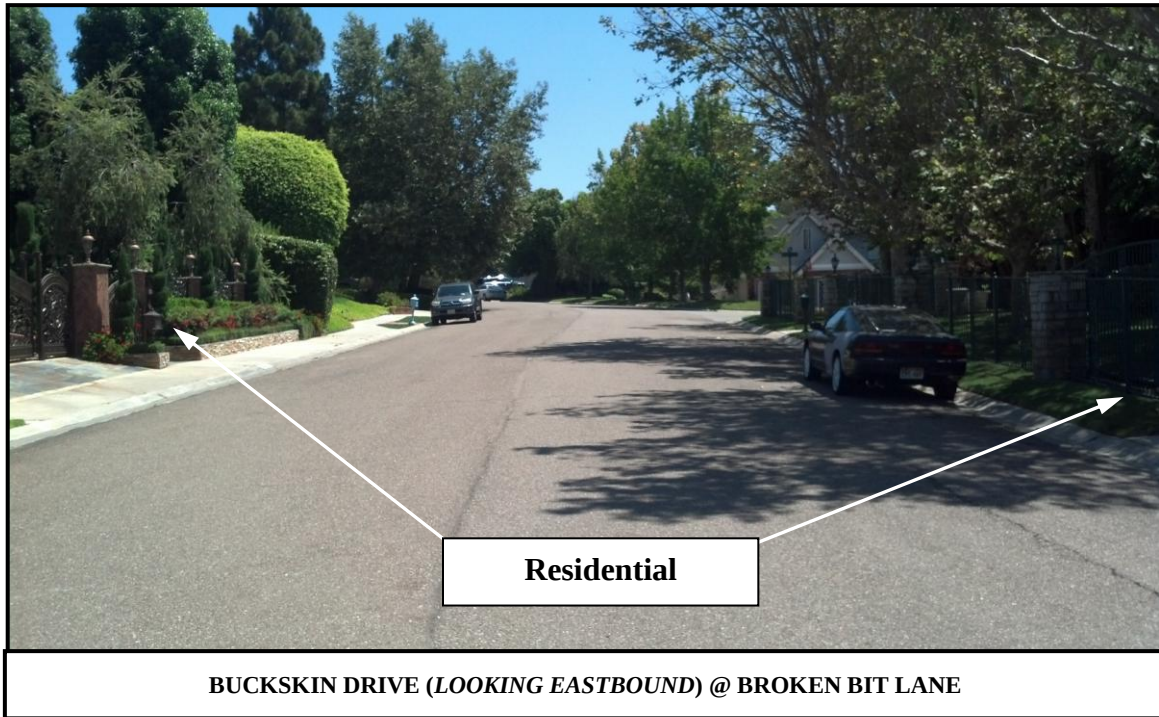
**EXHIBIT 1**

Buckskin Drive is a 40-foot wide, curvy, east-west local collector roadway with primarily residential frontage on both sides of the street. The two-lane roadway provides for one lane of traffic in each direction, which are not separated by any centerline striping. The roadway is fully-improved with concrete rolled curb and gutter on both sides, and sidewalk on the north-side only. Buckskin Drive has a posted speed limit of 25 miles per hour (MPH). On-street parking is allowed on both sides of the roadway. There is no regulatory signage controlling traffic on Buckskin Drive (uncontrolled) at its intersection with Broken Bit Lane.

*See Exhibit 1 (next page) for photo images of Buckskin Drive.*

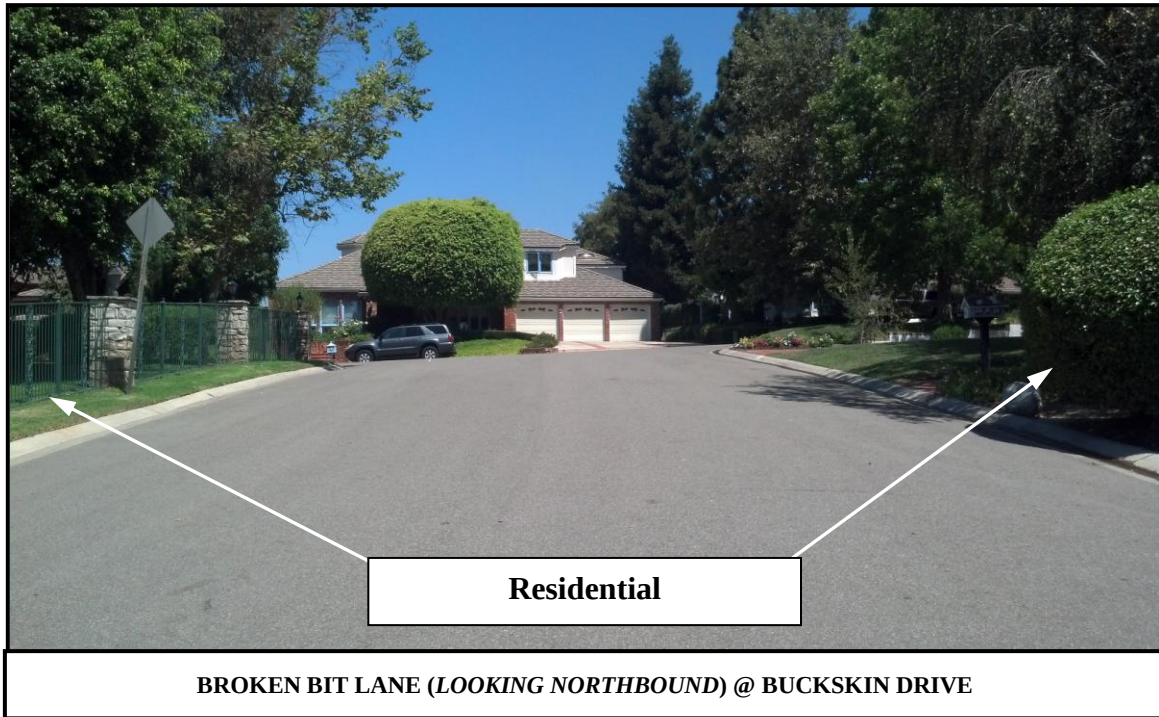
**EXHIBIT 2**

Broken Bit Lane is a 34-foot wide, curved, north-south local cul-de-sac roadway with residential frontage on both sides. Broken Bit Lane has a northerly terminus at its intersection with Buckskin Drive. The two-lane roadway provides for one lane of traffic in each direction, which are not separated by any striping. The roadway is fully-improved with concrete rolled curb and gutter on both sides (no sidewalk). Broken Bit Lane does not have a posted speed limit; however, the residential nature of this street results in a ‘*prima facie*’ speed limit of 25 MPH and does not require posting. On-street parking is allowed on both sides of the roadway. There is no regulatory signage controlling traffic on Broken Bit Lane (uncontrolled) at its intersection with Buckskin Drive.

*See Exhibit 2 (following page) for a photo image of Broken Bit Lane.*
