# **CITY OF LAGUNA HILLS TRAFFIC COMMISSION**

## **REGULAR MEETING AGENDA Wednesday, September 15, 2021 – 7:00 PM**

**3. PRESENTATIONS****4. ADMINISTRATIVE REPORTS****4.1 Nellie Gail Road Equestrian Crossing Update of Improvements and Consideration of a Raised Intersection**

***Traffic Control & Operational Review:***  
***Nellie Gail Equestrian Center Driveway/Equestrian Crossing Location, in Laguna Hills, CA***

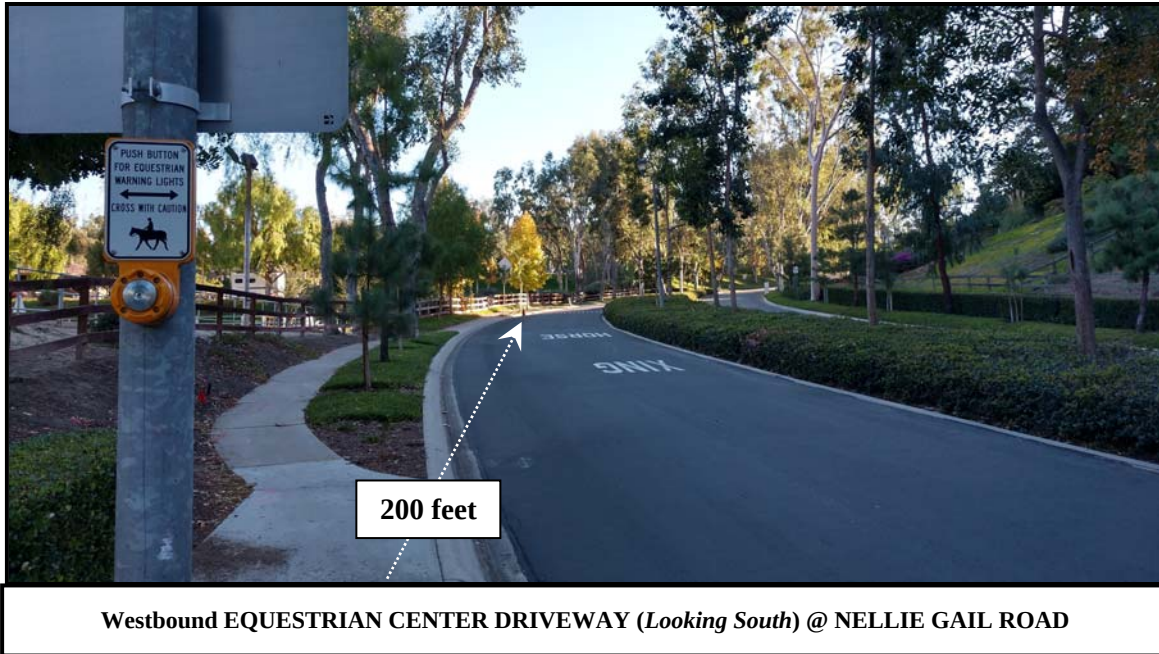
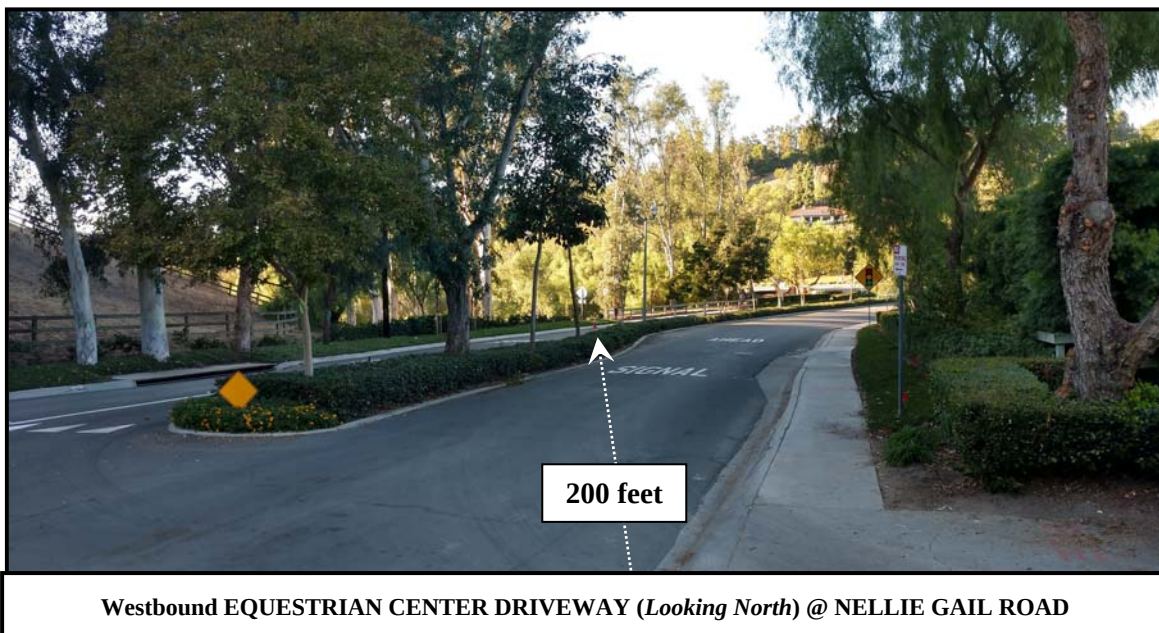
**EXHIBIT 1**

Driver sight distance was measured from the side-street approach, as westbound traffic on the Equestrian Center driveway is required to stop, before proceeding to make a left or right-turn onto Nellie Gail Road. The measured distance was derived from the stopping sight distance guidelines found in the California MUTCD (*see Appendix D*). In this reference, a 25 MPH roadway speed recommends a minimum Stopping Sight Distance of 155 feet. However, as shown, the 85<sup>th</sup> percentile speeds exceed the 25 MPH posted speed limit. Therefore, a 30 MPH speed limit was used as a more conservative measure, which has a minimum sight distance of 200 feet. This distance was used when looking towards approaching, uncontrolled traffic along Nellie Gail Road. More specifically, this stopping sight distance was field-measured from a typical ‘stopped’ vehicle location at the Equestrian Center driveway looking towards the oncoming lanes of cross-traffic on Nellie Gail Road. An orange cone was placed at this distance and a photograph was taken from a stopped driver’s perspective (i.e., approximately 4.5’ high above ground).

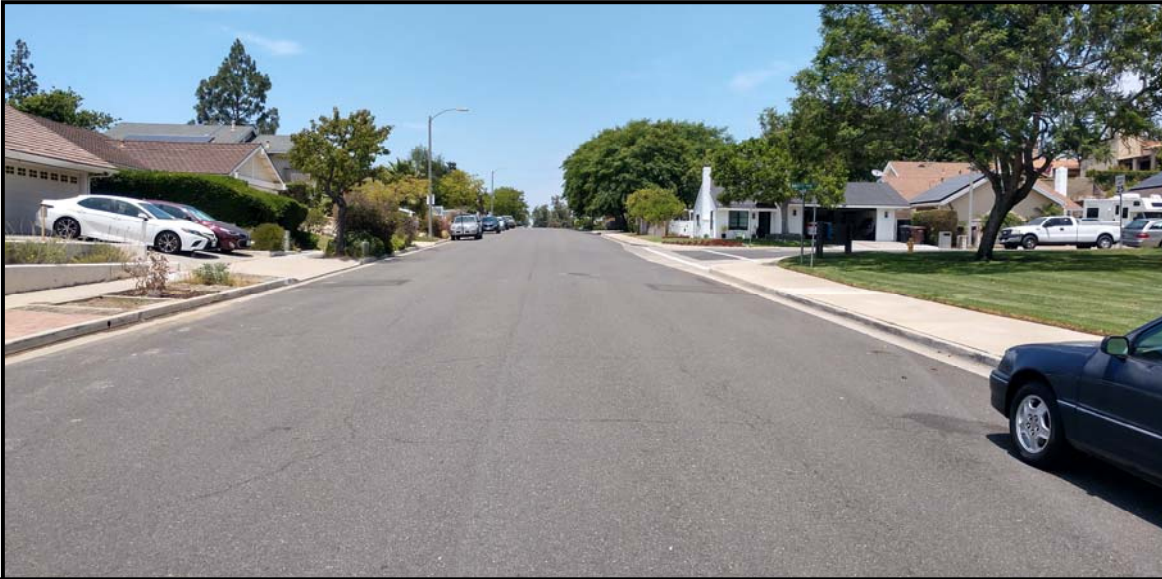
**MACKENZIE STREET (Looking Northbound) @ KNOTTY PINE ROAD**

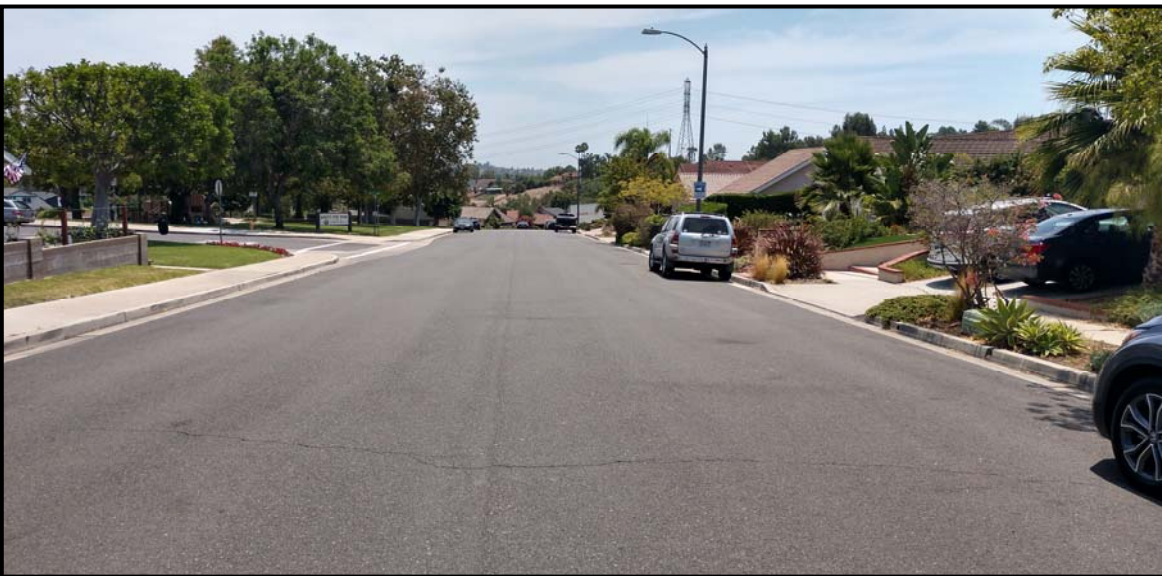
**MACKENZIE STREET (Looking Southbound) @ KNOTTY PINE ROAD**

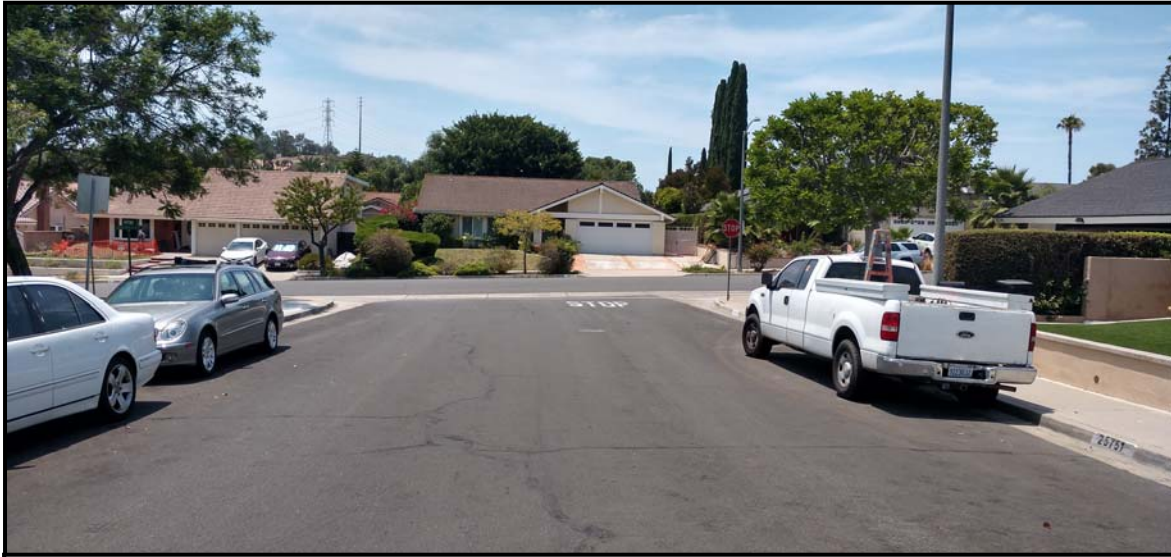
**KNOTTY PINE ROAD (Looking Westbound) @ MACKENZIE STREET**
